# HOME INSPECTION REPORT

## COMPREHENSIVE PROPERTY ASSESSMENT

| <b>PROJECTNAME</b><br>Sample Report | <b>UNIT NUMBER</b><br>XXX |
| <b>REPORT NUMBER</b><br>MAYNAA/HI/P/3DFDA0D9 | <b>INSPECTIONTYPE</b><br>Pre-possession |

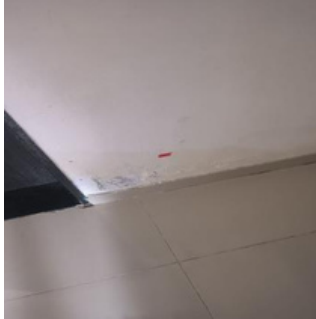
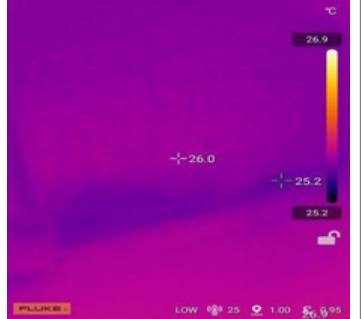
| AREA | Issue Observed | Actual Image | Thermal Image |
|---|---|---|---|
| Bathroom 2 Outside wall | Seepage was observed on the wall during the thermal camera inspection. The source of seepage should be identified and rectified, and the affected area should be repaired and waterproofed to prevent further moisture ingress. | | |

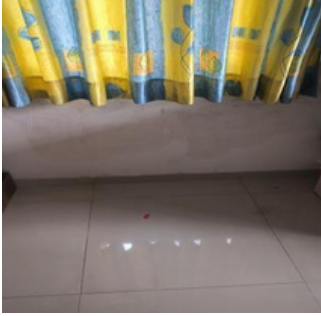
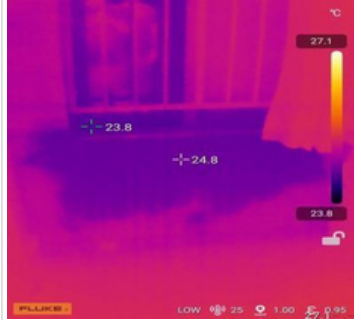
| AREA | Issue Observed | Actual Image | Thermal Image |
|---|---|---|---|
| Bedroom 1(Master Bed) | Seepage was observed below the bedroom window during the thermal camera inspection. The source of seepage should be identified and rectified, and the affected area should be repaired and waterproofed to prevent further moisture ingress. | | |

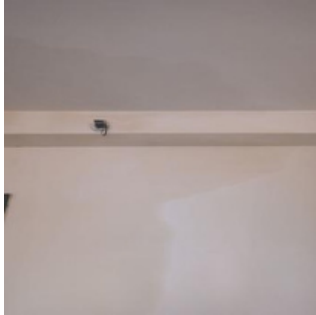
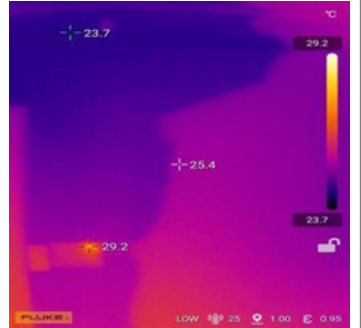
| AREA | Issue Observed | Actual Image | Thermal Image |
|---|---|---|---|
| Living Room | Seepage was observed on the living room wall and ceiling during the thermal camera inspection. The source of seepage should be identified and rectified, and the affected areas should be repaired and waterproofed to prevent further moisture ingress. | | |

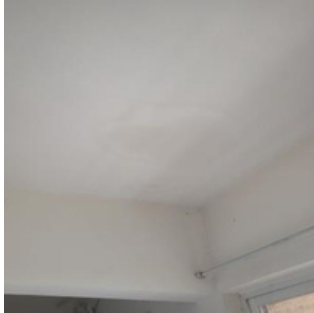
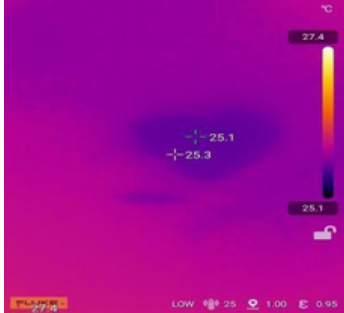
| Kitchen | <p>Seepage was observed on the kitchen room ceiling during the thermal camera inspection. The source of seepage should be identified and rectified, and the affected areas should be repaired and waterproofed to prevent further moisture ingress.</p> | A photograph showing a close-up of a white ceiling in a kitchen. There is a visible dark, irregular stain on the ceiling, indicating water seepage. | A thermal camera image of the same kitchen ceiling area. The image shows a color-coded temperature map. A central area is highlighted in yellow and orange, indicating a higher temperature (around 25.1°C and 25.3°C) compared to the surrounding cooler areas (purple and blue, around 27.4°C). A color scale bar on the right indicates temperatures from 25.1 to 27.4°C. The bottom of the image shows technical data: "LOW 25 1.00 0.95". |

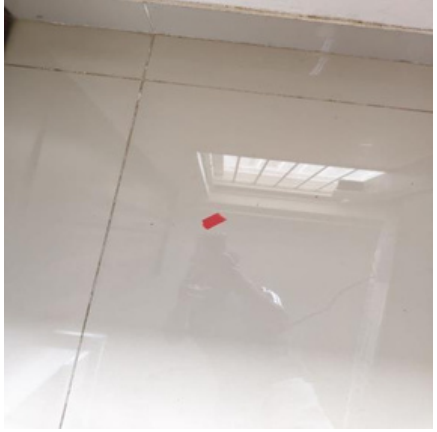
| Living Room | | | | |
|---|---|---|---|---|
| 1 | A hollow-sounding tile was observed during a tamping test hollow tiles was found in the living room | Living Room | Major | |

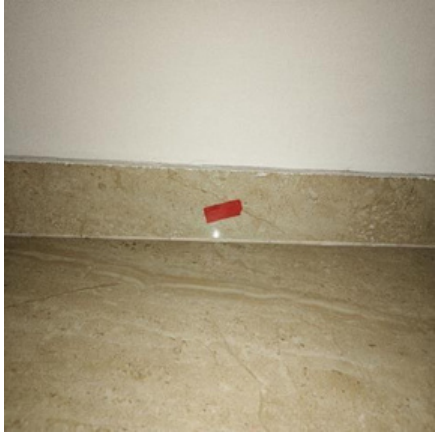
| Living Room | | | | |
|---|---|---|---|---|
| 2 | Hollow Skirting Found During a tamping test hollow skirting was found in living room | Living Room | Medium | |

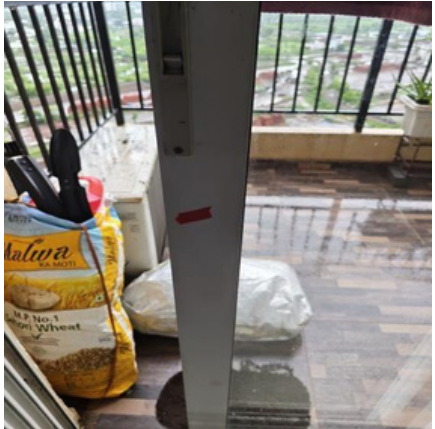
| 4 | The window does not operate smoothly and requires excessive force to open and close. window does not operate smoothly and locking mechanism was not functioning properly | Living Room | Medium | |

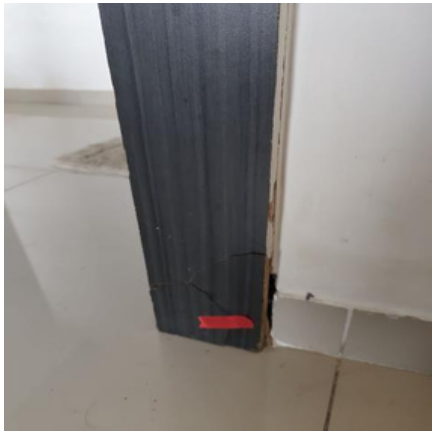
| 5 | The door frame was found to be damaged at the bottom edge, with visible chipping and surface deterioration. The damaged portion should be repaired or replaced and properly refinished to restore its appearance and prevent further damage. | Living Room | Major | |

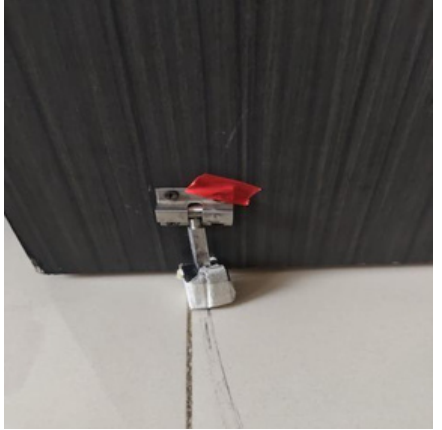
| 6 | The floor-mounted door stopper was found to be loose and improperly fixed. It should be securely refixed or replaced to ensure proper door stopping and prevent damage to the door and surrounding surfaces. | Living Room | Medium | |

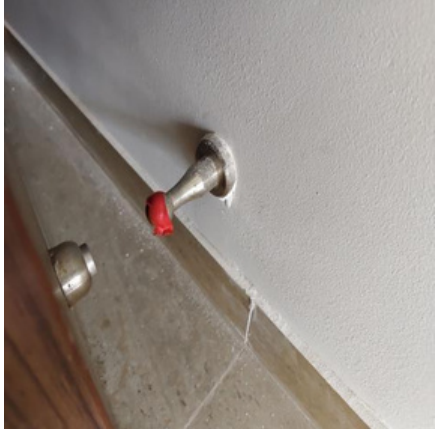
| 7 | The door stopper was found to have low holding strength and did not effectively restrict the door movement. It should be adjusted or replaced to ensure proper holding performance and prevent damage to the door or adjacent surfaces. | Living Room | Low | |

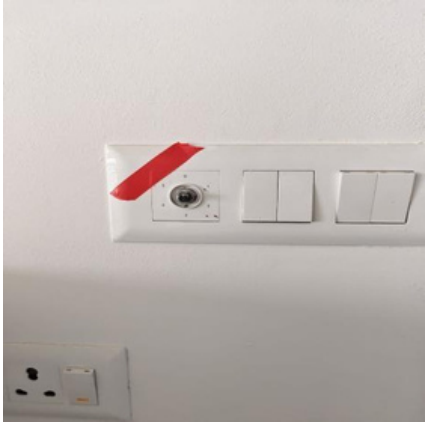
| Kitchen | | | | |
|---|---|---|---|---|
| 8 | The fan regulator knob was found to be missing. A suitable regulator knob should be provided and properly fitted to ensure smooth operation of the fan. | Kitchen | Low | |

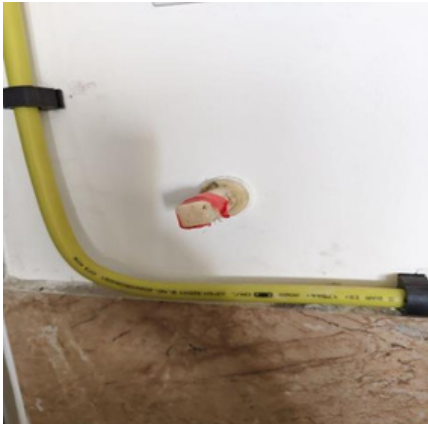
| Kitchen | | | | |
|---|---|---|---|---|
| 9 | The RO faucet was found to be missing. A suitable RO faucet should be provided and properly installed to ensure the RO system can be used effectively. | Kitchen | Major | |

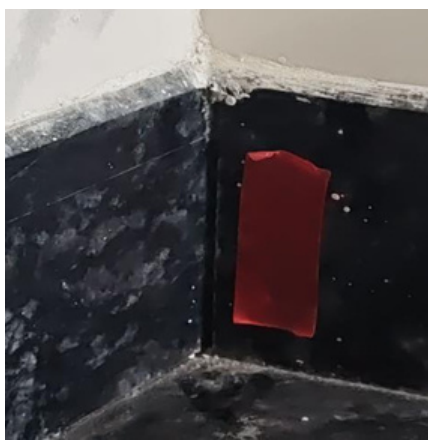
| Kitchen | | | | |
|---|---|---|---|---|
| 10 | Grouting was not done properly | Kitchen | Low | |

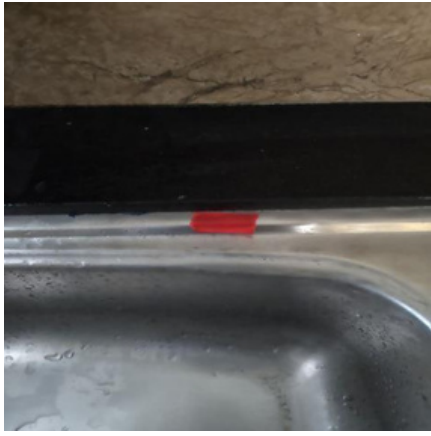
| 11 | Grouting was not done properly | Kitchen | Low | |

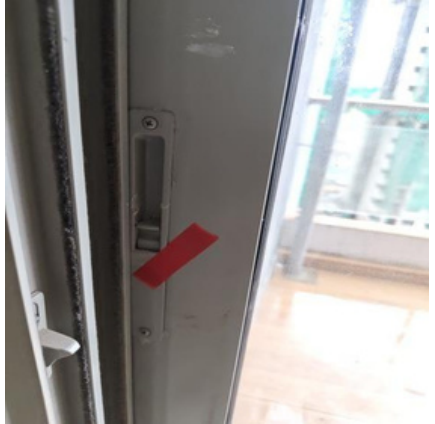
| Bedroom 1 | | | | |
|---|---|---|---|---|
| 12 | The windowlock was found to be malfunctioning and did not operate properly. It should be repaired or replaced to ensure smooth operation and secure locking of the window. | Bedroom 1 | Medium | |

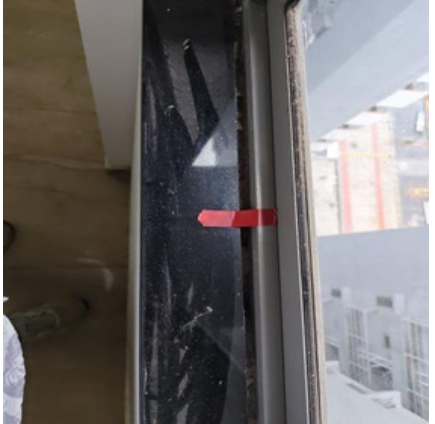
| Bedroom 1 | | | | |
|---|---|---|---|---|
| 13 | Grouting was not done properly | Bedroom 1 | Low | |

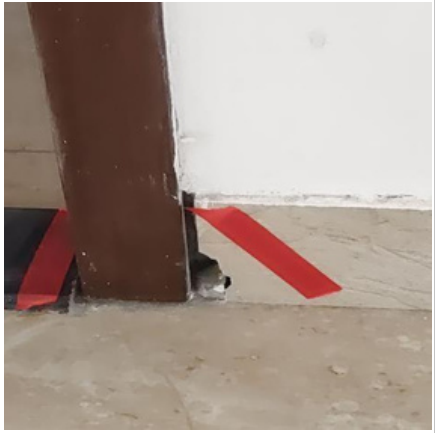
| Bedroom 2 | | | | |
|---|---|---|---|---|
| 14 | The skirting was found to be damaged near the door frame. The damaged skirting should be repaired or replaced and properly finished to restore its appearance and durability. | Bedroom 2 | Medium | |

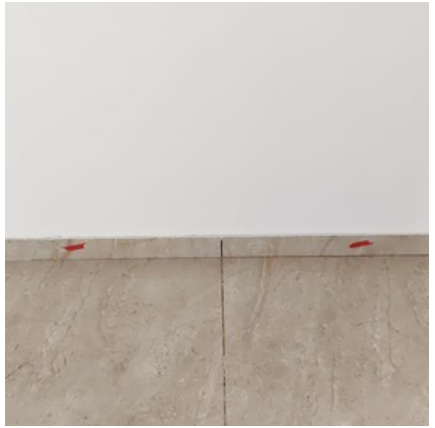
| Bedroom 3 | | | | |
|---|---|---|---|---|
| 15 | Hollow sounding skirting was found | Bedroom 3 | Medium | |

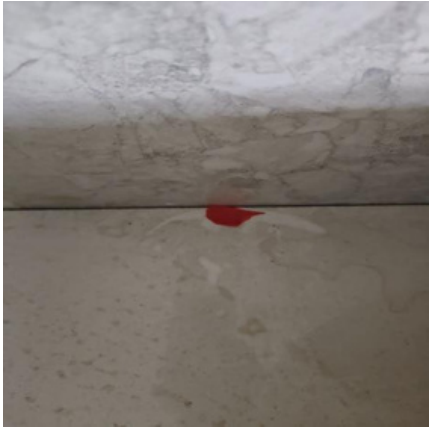
| Bathroom 1 | | | | |
|---|---|---|---|---|
| 16 | Grouting wasnot done properly | Bathroom 1 | Low | |

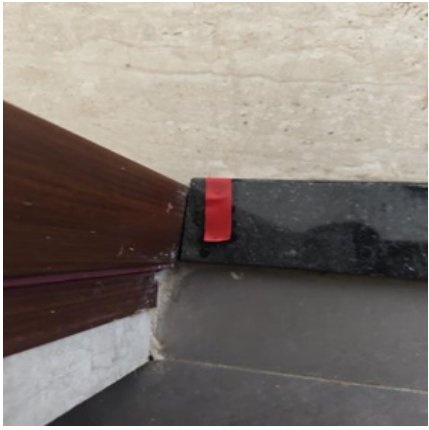
| Bathroom 1 | | | | |
|---|---|---|---|---|
| 17 | Grouting was not done properly | Bathroom 1 | Low | |

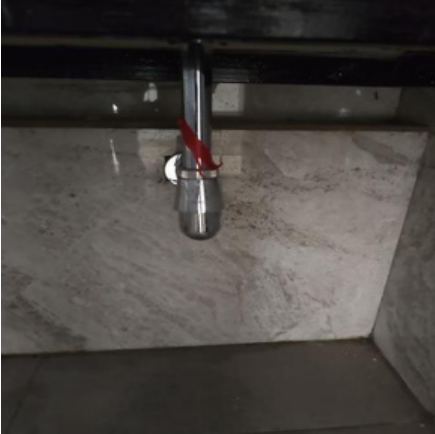
| 18 | Leakage was found beneath the wash basin due to a loose plumbing fitting. The loose fitting should be properly tightened or replaced to stop the leakage and ensure a leakfree plumbing connection. | Bathroom 1 | Major | |

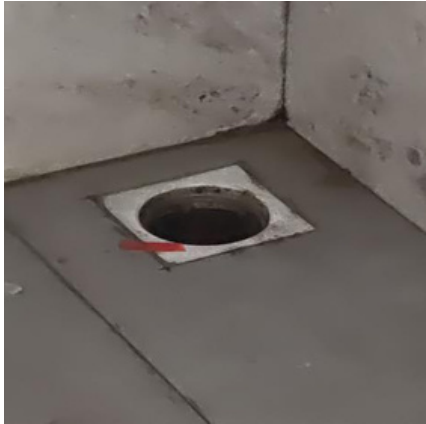
| 19 | The floor drain cover was found to be missing. A suitable floor drain cover should be provided and properly installed to ensure safety and prevent debris from entering the drainage system. | Bathroom 1 | Low | |

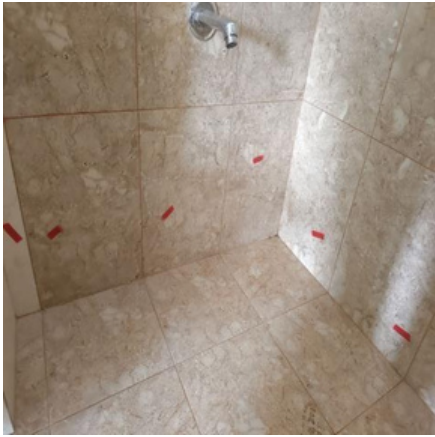
| 20 | A hollow-sounding tile was observed. | Bathroom 1 | Major | |

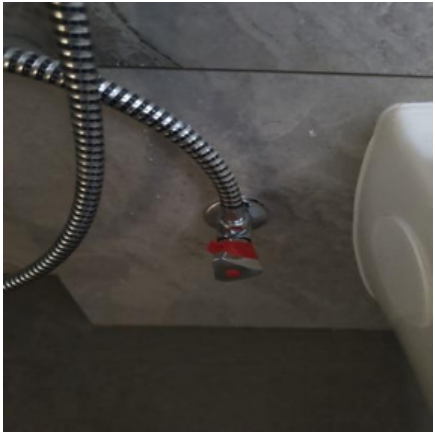
| Bathroom 2 | | | | |
|---|---|---|---|---|
| 21 | The jet sprayangle knob was found to have a loose fitting. It should be properly tightened or replaced to ensure smooth operation and prevent leakage. | Bathroom 2 | Medium | |

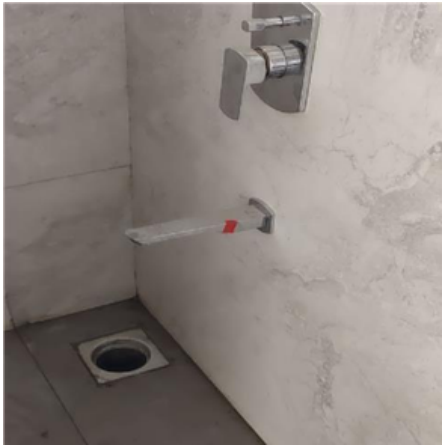
| Bathroom 2 | | | | |
|---|---|---|---|---|
| 22 | The water tap was found to have a loose fitting, resulting in water leakage from its base. The fitting should be properly tightened or resealed to prevent leakage and ensure proper operation. | Bathroom 2 | Major | |

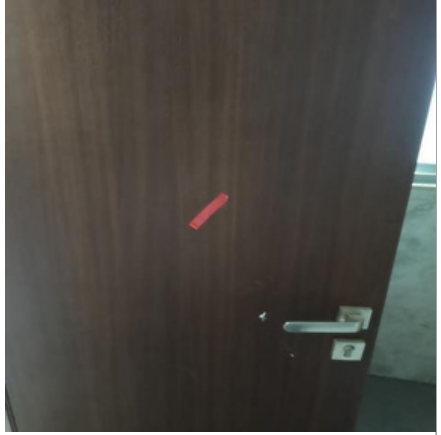
| Bathroom 3 | | | | |
|---|---|---|---|---|
| 23 | The door was found to be operating roughly and required excessive force to open and close. The door alignment, hinges, and hardware should be inspected and adjusted to ensure smooth operation. | Bathroom 3 | Major | |

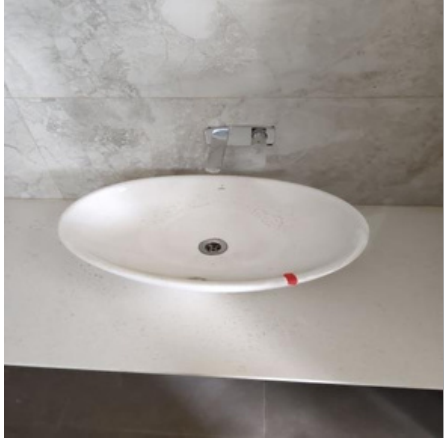
| Bathroom 3 | | | | |
|---|---|---|---|---|
| 24 | The wash basin was found to be improperly aligned. The basin should be realigned and securely fixed to ensure proper installation and an improved finish. | Bathroom 3 | Low | |

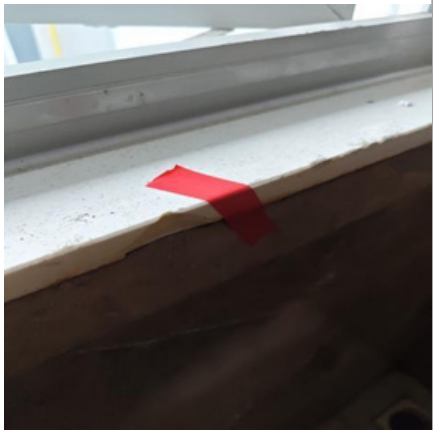
| Bathroom 3 | | | | |
|---|---|---|---|---|
| 25 | The edges of the bathroom window granite/marble sill were found to be chipped. The chipped edges should be repaired, polished, or replaced to achieve a proper finish and prevent further damage. | Bathroom 3 | Medium | |

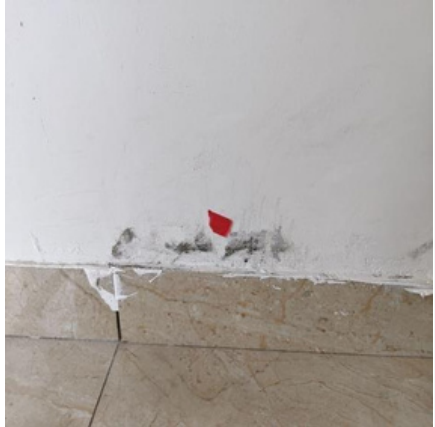
| Dining area | | | | |
|---|---|---|---|---|
| 26 | The wall paint was found to be damaged and poorly finished near the skirting. The affected area should be properly prepared, repainted, and finished to achieve a uniform appearance. | Dining area | Medium | |

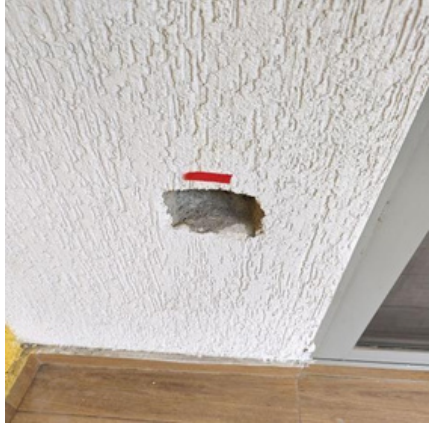
| Bedroom 1 Balcony | | | | |
|---|---|---|---|---|
| 27 | The wall finish was found to incomplete, with plaster exposed. The affected area should be properly repaired, finished, and painted to achieve a uniform appearance. | Bedroom 1 be Balcony | Major | |

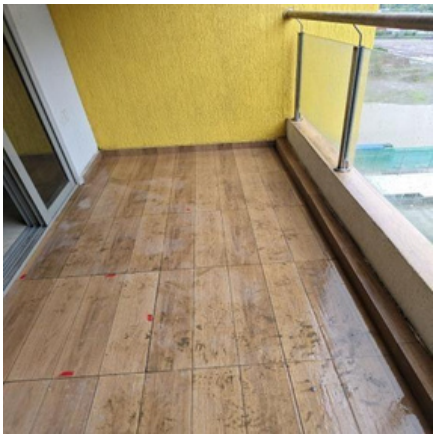
| Balcony | | | | |
|---|---|---|---|---|
| 28 | The balcony floorslope was found to be improper, causing water to stagnate. The floor should be re-leveled to provide the required slope towards the drain and ensure proper water drainage. | Balcony | Major | |

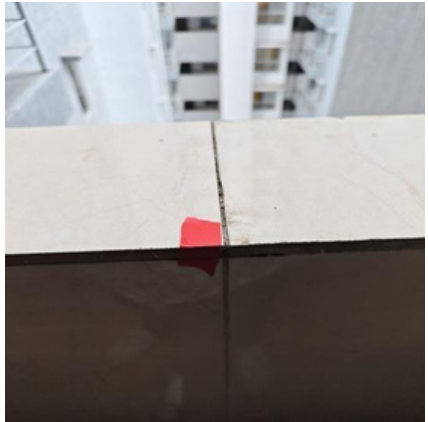
| Dry Balcony | | | | |
|---|---|---|---|---|
| 29 | Grouting wasnot done properly | Dry Balcony | Low | |
